Manhole Inspection Summary

Manhole # S49MM_009MH

Record Plat: **49MM** Node: **009** Status: **Found**

Location Address: **Belair rd**

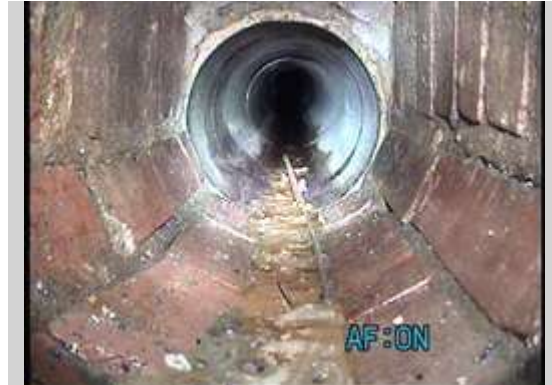
12 O'Clock Outflow
Pipe Out @ 12 O'Clock

Pipe Height: **8.4** (in.) Rod and Bar (Angled)
Pipe Material: **Clay** ☐ Pipe Lined
Invert Depth: **8.80** (ft.) Flow Characteristics: **None**
Deposits: ☒ None ☐ Mud ☐ Sludge ☐ Debris ☐ Grease
Silt Depth: (in.) Deposits Extent:
Infiltration: **None** Pipe Seal Cond: **Sound**
